The State of New Hampshire
DEPARTMENT OF ENVIRONMENTAL SERVICES

September 6, 2018
Letter of Deficiency
DSP #18-039

RE: Vilas Pool Dam #D005006, Alstead

Dam #D005006, Vilas Pool Dam, Alstead, Inspected on 07/17/17

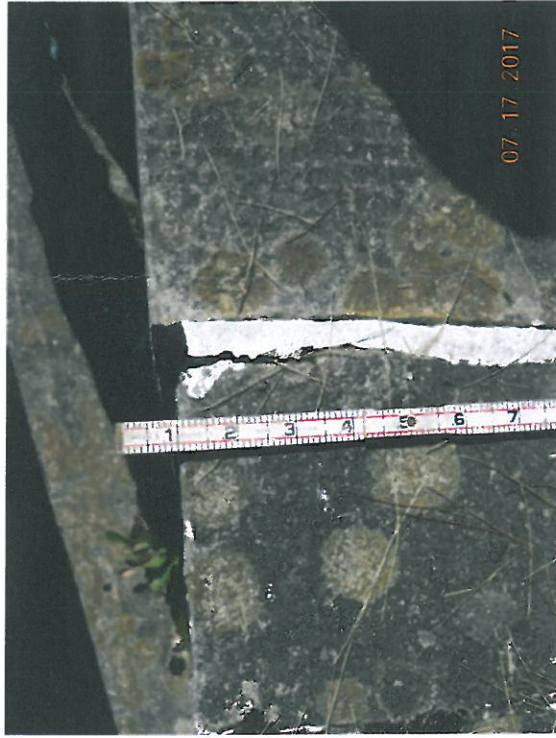
A

1. The crack running through the left abutment (located approximately 8 ft. left of the spillway). This crack was measured as having a $\frac{3}{4}$ " displacement. NHDES recommends installing pins to measure any movement/displacement. Notify the Dam Safety Office if any changes occur. (See photos A, B and C).

- c. The structural cracking and deterioration of concrete on the entire dam structure including, but not limited to, the following areas;
 - i. The $\frac{3}{4}$ " wide crack running through the left concrete abutment wall. (See photos A, B and C);

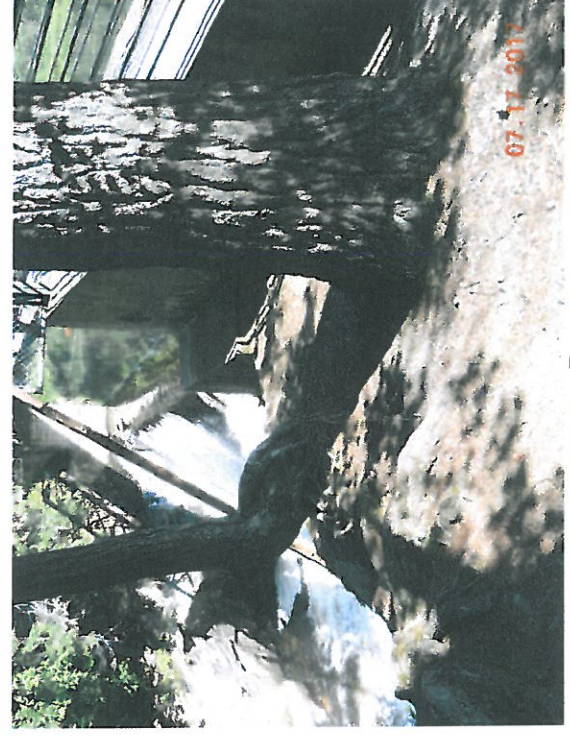
D

3. **Previously extended to December 1, 2012**, cut all trees, brush and weedy growth from the footprint (concrete structure) of the dam and 15 ft. beyond the footprint of the dam to prevent damage to the dam from root penetration, blow down of the trees and to create a buffer zone to monitor the dam for seepage and other maintenance concerns. Stumps can remain if cut flush with the adjacent ground. Trees on this site founded on ledge still present a hazard to the dam if toppled during a storm event and potentially cause blockage to the dam's spillway. Areas to clear include:
 - a. The pine trees directly downstream of the left concrete wall. (See photos D, E and F).

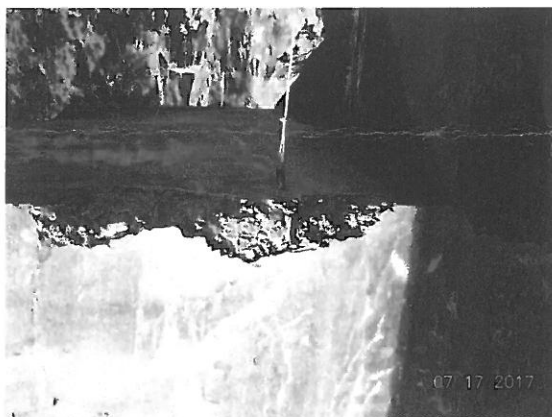
- ii. Right side upstream face of the abutment and wing. (See photos G and H);
 - iii. Left upstream training wall. (See photos I and J);
 - iv. Right side downstream face of the abutment; and

6. Engage the services of a consultant qualified** in dam-related work to complete an engineering evaluation or analysis of, at a minimum, the items noted below and submit a report to NHDES. The report should include all investigation findings and include recommendations and a schedule for repair, as warranted, to make the dam compliant with the current standards for significant hazard dams.
